Inspection Report

Property Address:
987 Bluffs Drive
Thistown Ia 65765

Date: 5/19/2015	Time: 4:15 PM	Report ID: Practice0002
Property: 987 Bluffs Drive Thistown Ia 65765	Customer: Justin Anderson	Real Estate Professional:

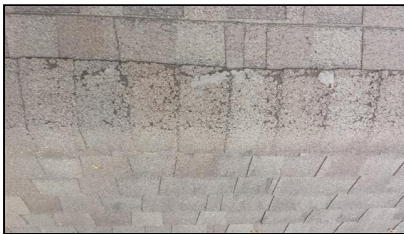
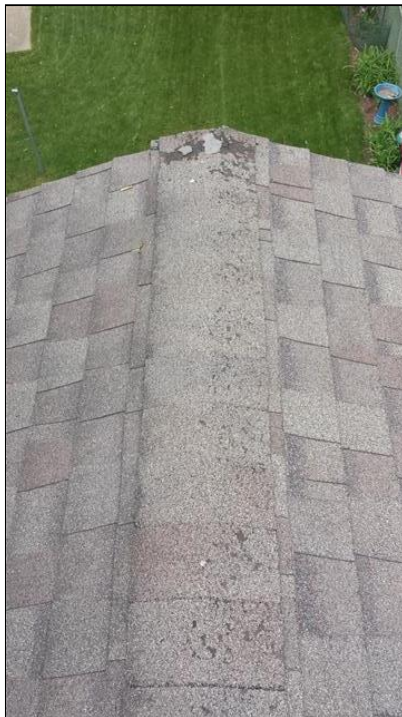
1.0 Item 1(Picture)

The roof covering is in poor overall condition. As you can see in the two pictures included you can see that the ridge cap shingles show extreme wear. I did not find any curling or cracking of the shingles but it does show the wear of a roof that is probably at least 20 years old. I was unable to find any evidence of leaking in the home but the roof covering should be replaced. According to the owner a new roof will be install next month.

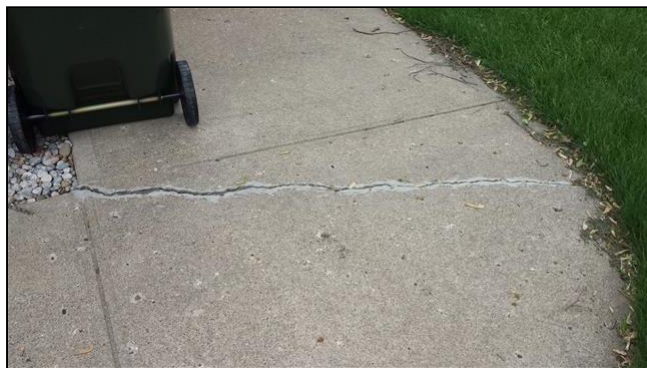
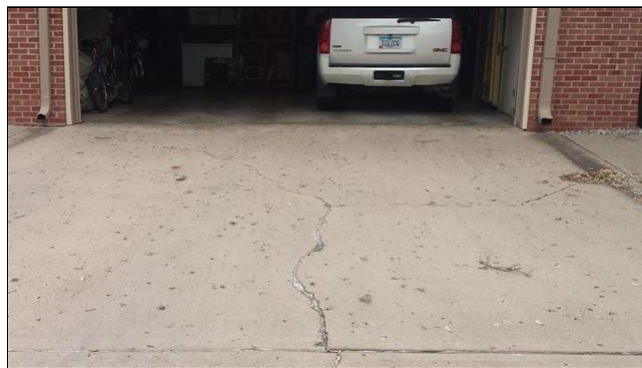
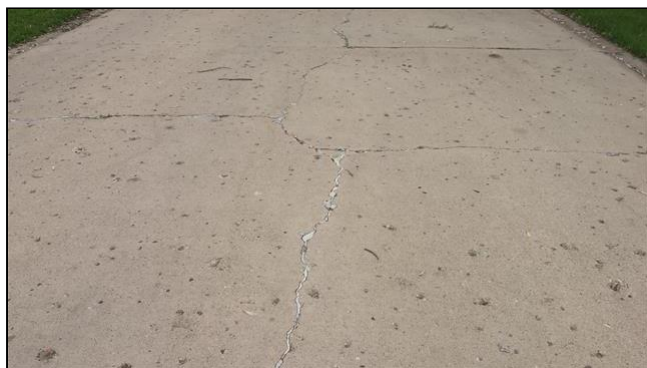
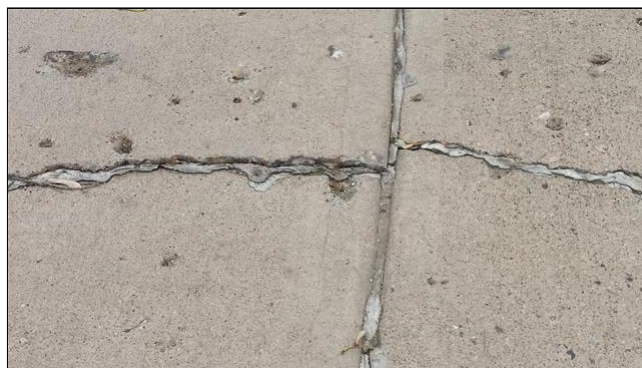
2.4 Item 1(Picture)

The ground around the house has the proper slope for drainage. There are several cracks in the sidewalk and driveway which is expected for the age of the house. The cracks have been sealed but should be monitored. There are no trip hazards found with these cracks.

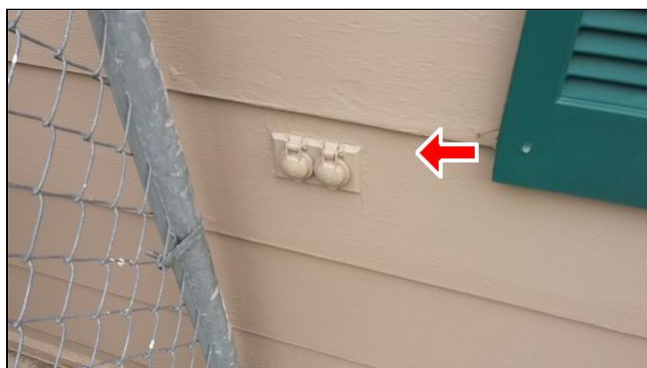
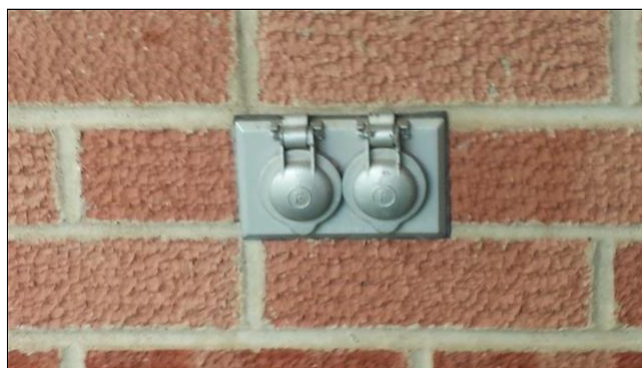
2.7 Item 1(Picture)

The current outlets are covered which protects them from the elements and though not necessary it is recommended that the exterior outlets of the house should be replaced with GFCI outlets.

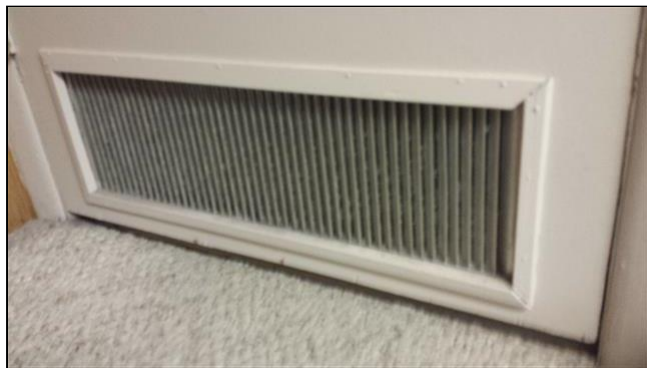
5.4 Item 1(Picture)

The door leading into the utility room in the basement has a vent to provide proper air circulation for the furnace. This vent should be cleaned to allow proper air flow.

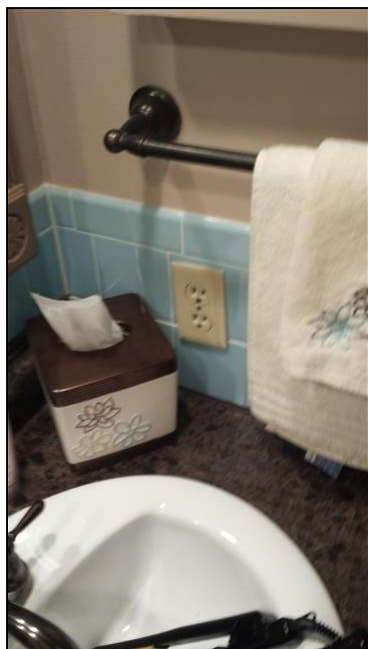
6.5 Item 1(Picture)

The fixtures in the upstairs hallway bathroom are in good working order. It is recommended that the outlet in this bathroom should be replaced with a GFCI outlet.

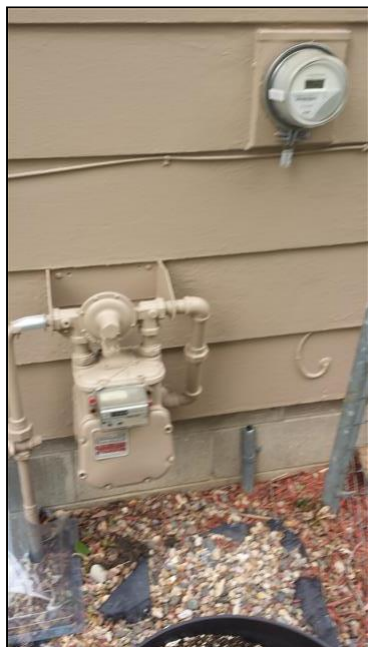
9.1 Item 1(Picture)

The main gas line and electrical meter are found on the south wall, east end of the house.
